# LESSONS WE CANNOT

Learning from ARLANXEO's  
Most Serious Incidents

By: Wael Abdelgalil

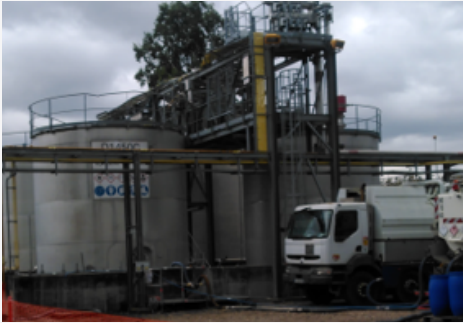
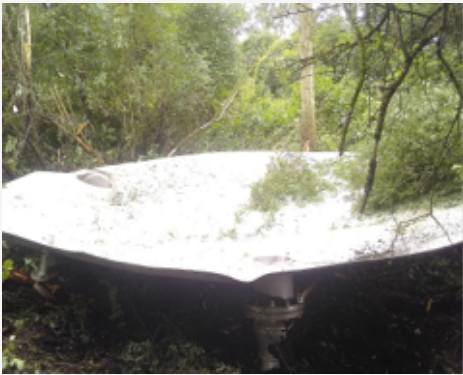
On Thursday, July 04, 2024, A water–acetonitrile (ACN) buffer tank was taken out of service to allow its scheduled internal inspection. The tank had been isolated from the process, drained of liquid, and prepared for cleaning before the inspection.

The force of the explosion caused the tank roof to separate along its designed weak seam. The roof was projected into undeveloped land adjacent to the production unit. Fortunately, no personnel were inside or near the tank at the time of the explosion, and there were no injuries.

Neither the site personnel nor the high-pressure cleaning contractor was aware that high-pressure water cleaning at pressures above 500 bar can generate electrostatic charge, even when the equipment is properly grounded. Consequently, the possibility of static discharge acting as an ignition source was not considered during the risk assessment, the job safety analysis, or the work planning process.

At the same time, cleaning activities disturbed residual deposits inside the tank, allowing a flammable atmosphere to develop. The focus on toxic exposure outside the tank diverted attention from the possibility of a flammable atmosphere forming inside it. The explosion occurred when these two conditions a flammable atmosphere and an ignition source came together.

High-pressure water cleaning can generate electrostatic charge capable of igniting flammable atmospheres, even when conventional grounding measures are in place.

Risk assessments should consider all hazards introduced by the cleaning method, not only the hazards associated with the process material.

Managing one hazard must not divert attention from another. Toxicity and flammability should always be assessed together where both are possible.
